Re: PRC Preliminary Assessment/Visual Site Inspection of
Columbus Coated Fabrics Final Report - April 21, 1993 - HRE-8J - Page 12

**Technical Enforcement Support
at Hazardous Waste Sites
Zone III
Regions 5,6, and 7**

COLUMBUS COATED FABRICS CORPORATION
COLUMBUS, OHIO

POTENTIAL HAZARDOUS WASTE SITE
PRELIMINARY ASSESSMENT
PART 1 - SITE INFORMATION AND ASSESSMENT

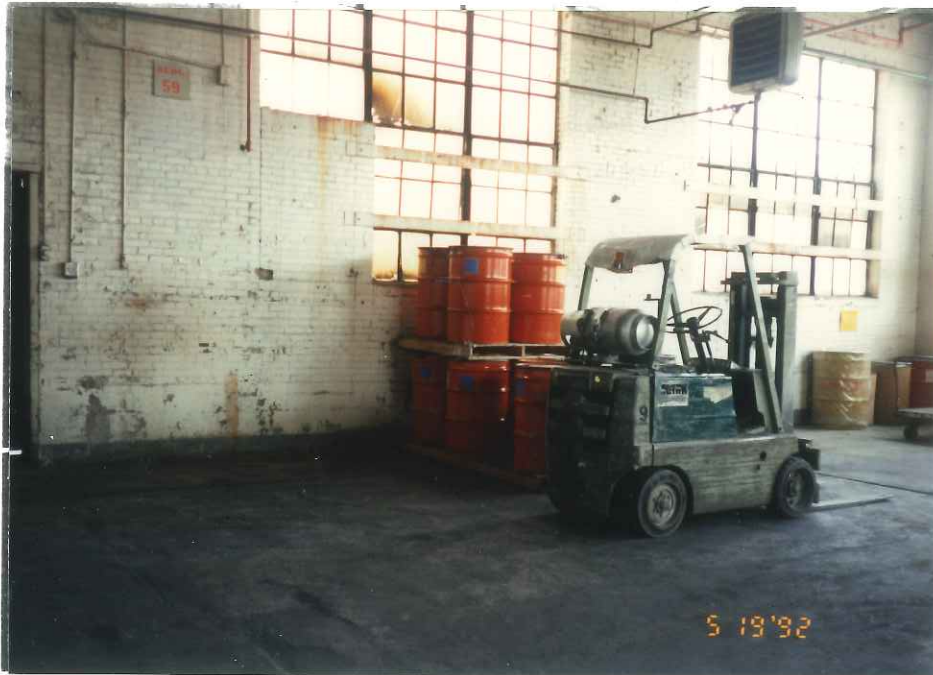
Location: SWMU 3
 Date: 5/19/92

Photograph No. 1
 Orientation: North
 Description: Drum staging area for Building 59 and 37

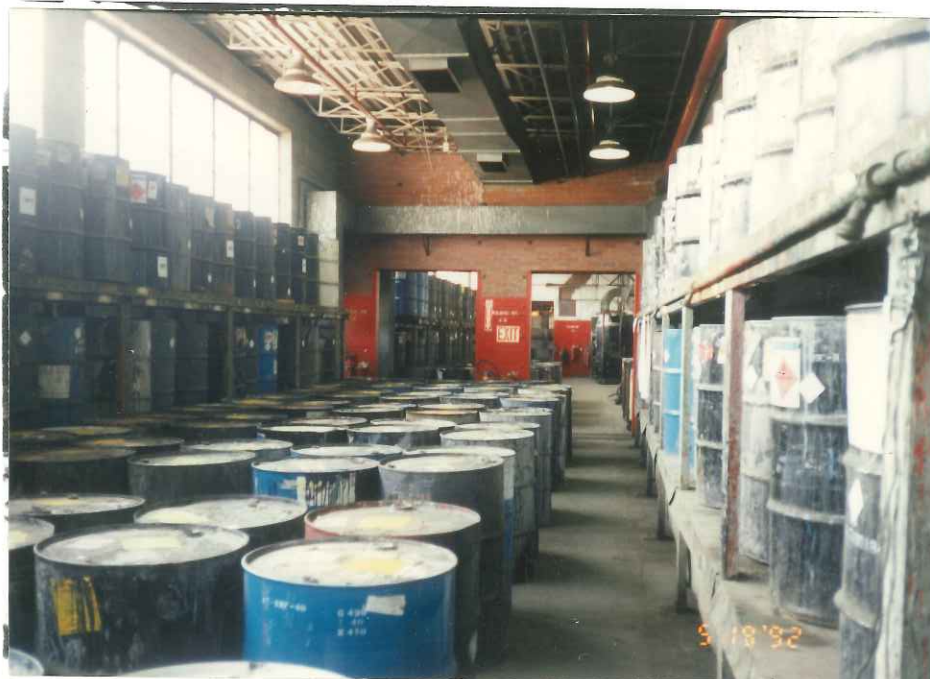
Location: SWMU 2
 Date: 5/19/92

Wastes are stored in 55-gallon drums in Building 95. One-hundred fifty-eight drums of waste, with hazardous waste labels dated with accumulation start dates ranging from May 6, 1992 to May 19, 1992, were present during the VSI. No cracks were present in the concrete floor. Small stains were observed on the floor of the unit during the VSI.

Photograph No. 2
 Orientation: North
 Description: Drums of hazardous waste are stored here until a tanker truck pumps the waste from the drums.

Recommendations: PRC recommends that soil sampling be performed and analyzed for volatiles, semivolatiles, and metals.

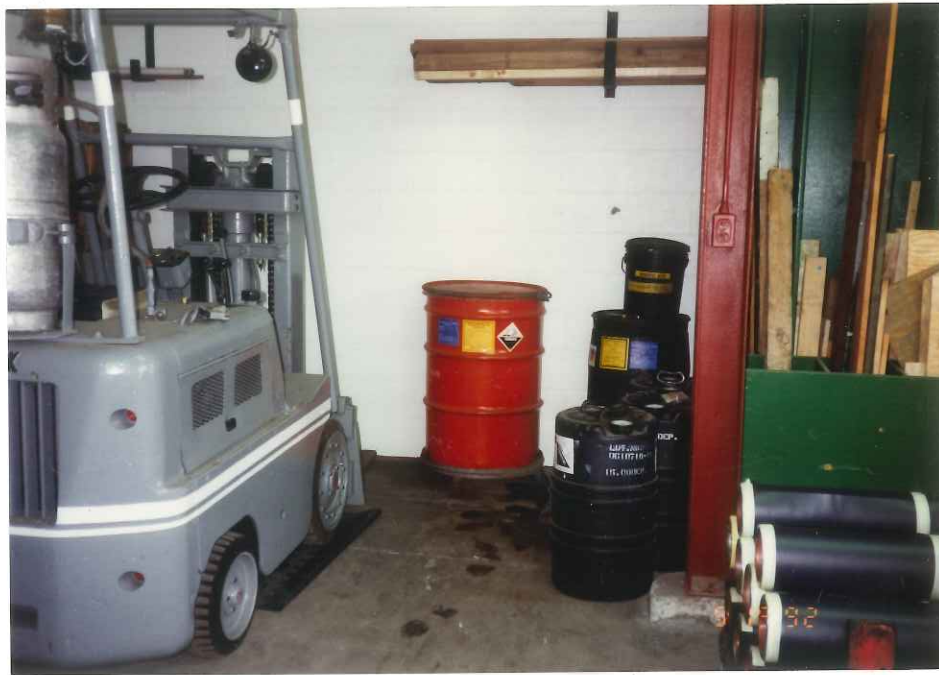
Location: SWMU 3
 Date: 5/19/92

Observations: This unit is located in the loading dock area of Building 101. Two partially filled 55-gallon drums of D002 and D007 waste were present at the time of the VSI. Several small brown stains were present on the floor in front of the drums.

Photograph No. 3
 Orientation: North
 Description: Building 101 Satellite Accumulation Area

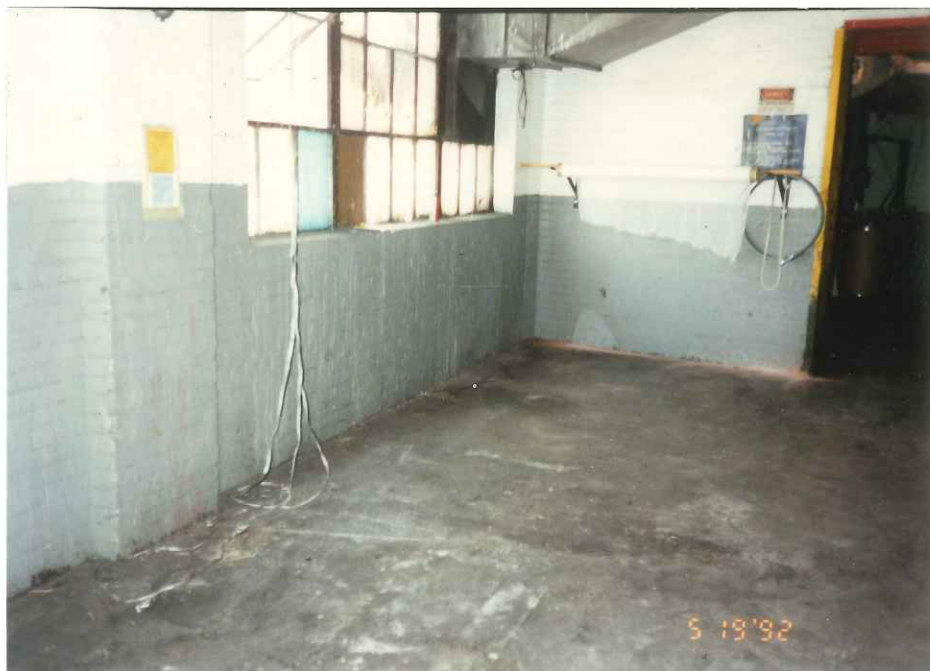
Location: SWMU 4
 Date: 5/19/92

Photograph No. 4
 Orientation: Southeast
 Description: Building 23 Satellite Accumulation Area. No waste was present at the time of the VSI.

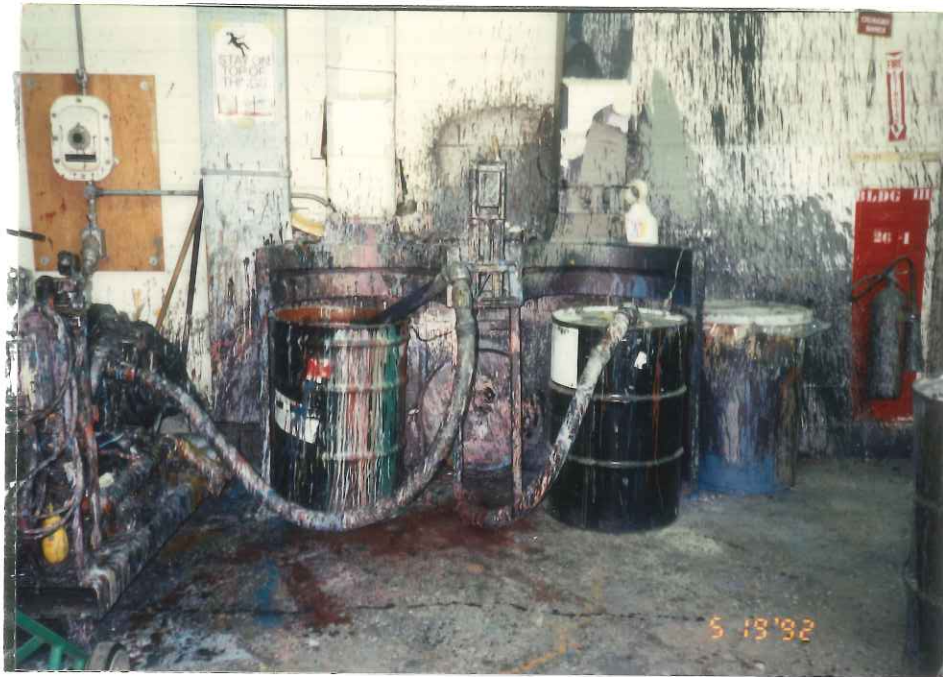
Photograph No. 5

For the SAAs in both Building 88 (SWMU 1) and Building 111 (SWMU 4), the potential for release to air is high. The units are located indoors on concrete floors but housekeeping practices are poor. Evidence of spills observed indicate that wastes are allowed to volatilize into the building's air space. A drum with an open funnel was also observed at the Building 88 SAA. PRC recommends the facility improve its waste management practices and store drums closed with no funnels in the bungs unless fill operations are in progress.

Unit Description: The Building 111 SAA is located in the northeast corner of the Building 111 (see Photograph No. 5). This unit is used for the

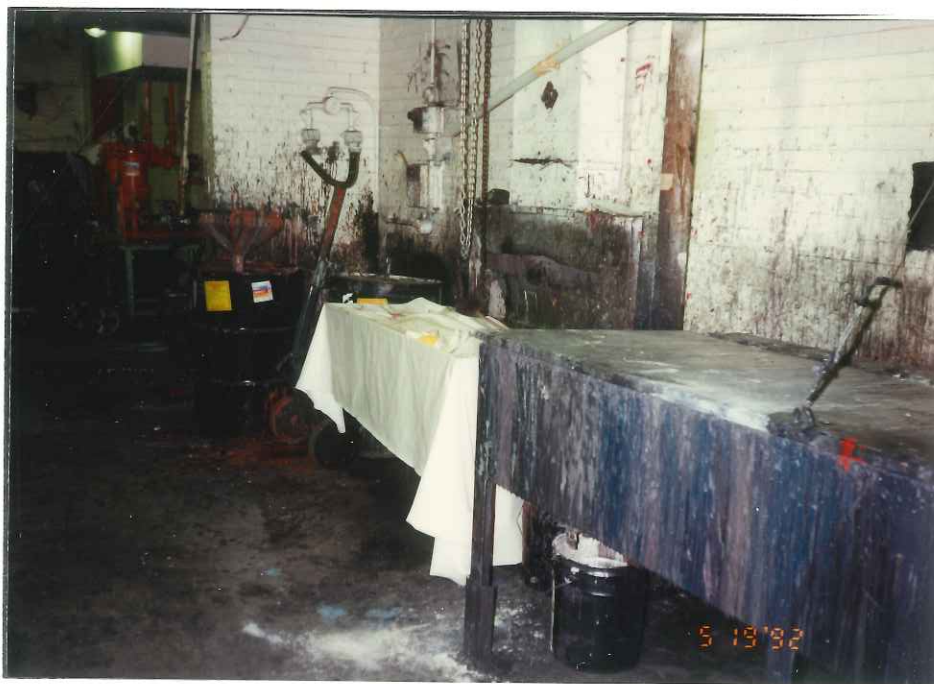
Photograph No. 6

The Building 88 SAA is located near the tray washing operations (see Photograph No. 6). This unit is located indoors on a concrete floor. This unit measures about 5 feet wide by 6 feet long. Waste is accumulated in 55-gallon drums that are placed directly on the concrete floor of the unit. No floor drains are present in the area.
